# PHASE I ENVIRONMENTAL SITE ASSESSMENT 570 BERCUT ROAD SACRAMENTO, CALIFORNIA

Prepared for:
California Department of General Services

January 2015

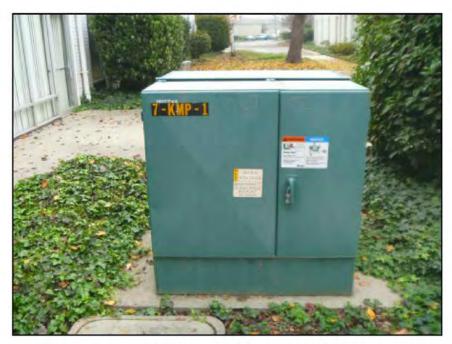
One pad mounted transformer is located on the northwestern corner of the Site. This transformer is identified as 7-KMP-1 and a PCB free label was not observed. Fugro attempted to contact Sacramento Municipal Utility District (SMUD) with no response received by the date of this report. No evidence of staining, leakage or odors was associated with the transformer

Transformer 7-KMD-1 on the northwest corner of the Site.

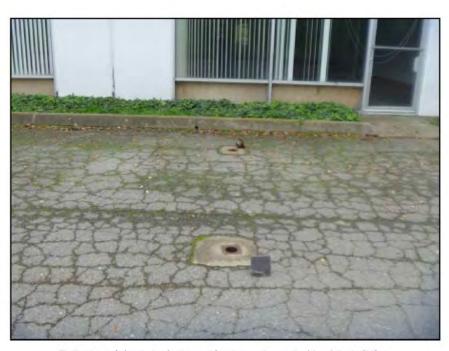
Bollard-receiving holes in the parking lot on the north side of the building.

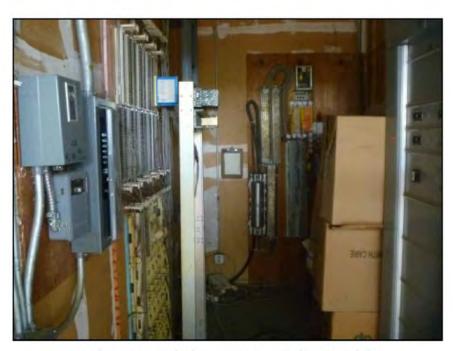
Electrical and communications room on the north side of the building.

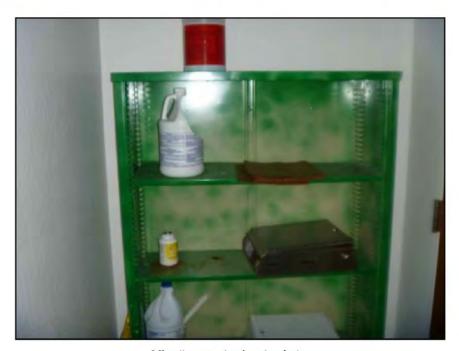
No hazardous materials were observed during the Site reconnaissance. Retail sized cleaning chemicals were observed inside a restroom and several cans of paint were observed inside the Site building, but no evidence of spills, leaks, or misuse was observed.

Miscellaneous cleaning chemicals.

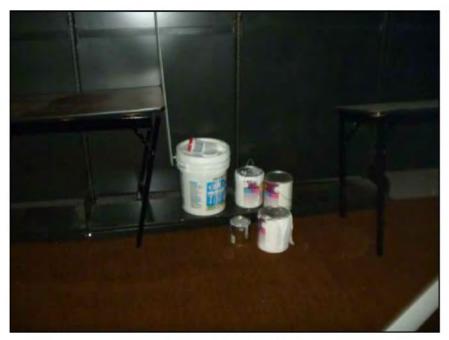
Miscellaneous paint cans stored on-site.

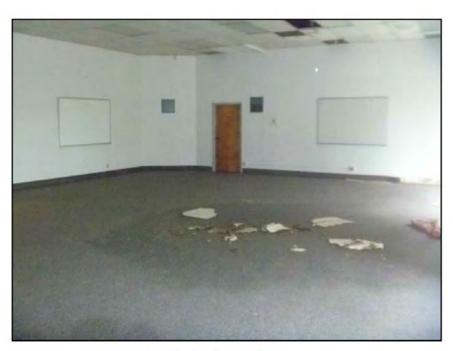
Water staining from roof leaks was observed at several locations in the Site building. No corrosion was observed during the Site reconnaissance. Several rooms exhibit a musty odor, suggesting that the water leaks may have caused mold growth.

Example of roof leak in a large room.

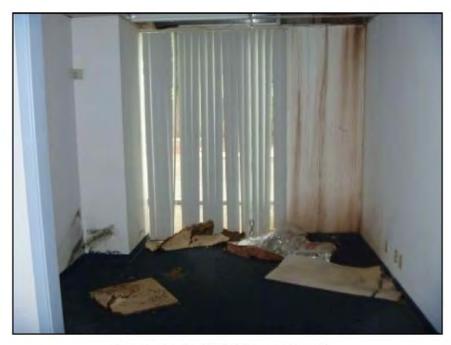
Example of roof leak and visible mold in an office.

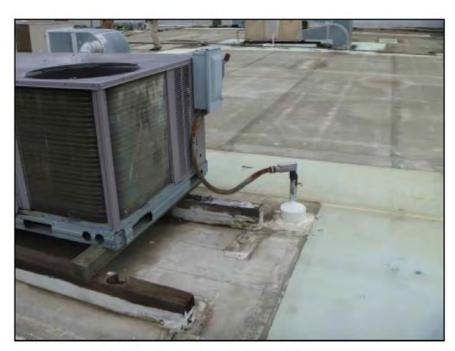
Multiple heating, ventilation, and cooling (HVAC) systems were observed on the roof of the Site building. These HVAC systems were apparently powered by electricity. All the systems were shut off during the Site reconnaissance.

Typical HVAC unit on the roof, with electrical power source.
